## SIDEWALK TRIP HAZARD REPAIR SUMMARY: PHASE II

Presented to: Cubb Stokes  
January 2017

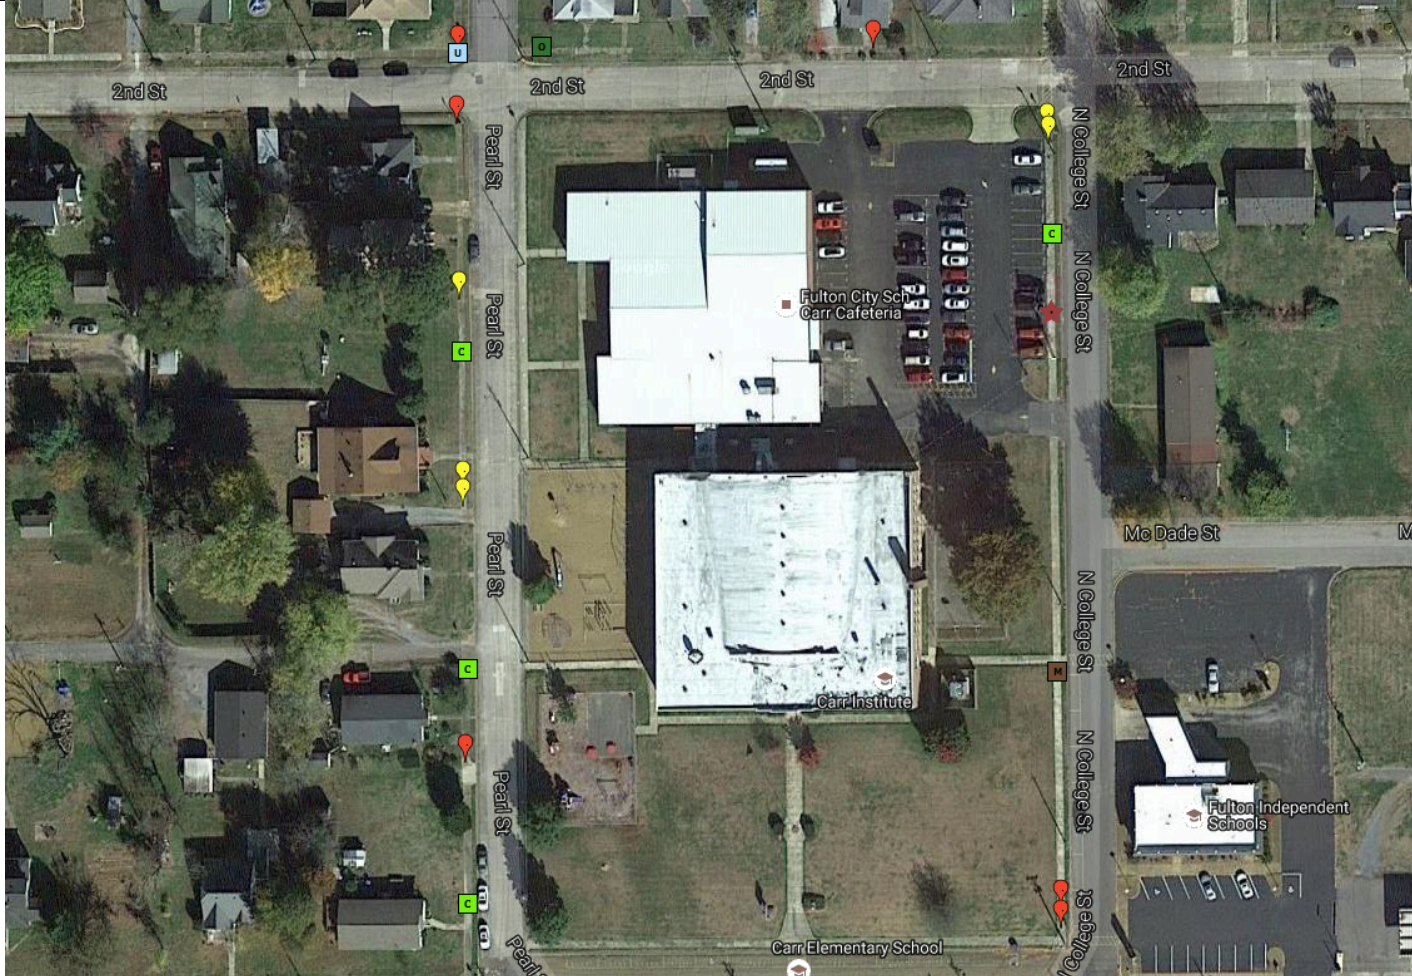
# PEARL ST / N COLLEGE ST / 2ND ST

<b>C</b> : Cracking	<b>M</b> : Missing	<b>O</b> : Overgrown	<b>●</b> : 1/4" to 3/8"
<b>S</b> : Spalling	<b>H</b> : Heaving	<b>★</b> : Multiple	<b>●</b> : 1/2" to 2"
<b>U</b> : Utility	<b>T</b> : Tree Damage

The map in this project summary shows the resolution area for trip hazards in this part of the city. The area has been surveyed for trip hazards for audit and trends. The accuracy of these maps is dependent on smart phone technology available, and should be relied upon as approximations.
